Helping Iraqis Rebuild Iraq

By Colonel James I. Vosler, Lieutenant Colonel Clarence D. Turner, and Captain Kevin J. Schrock

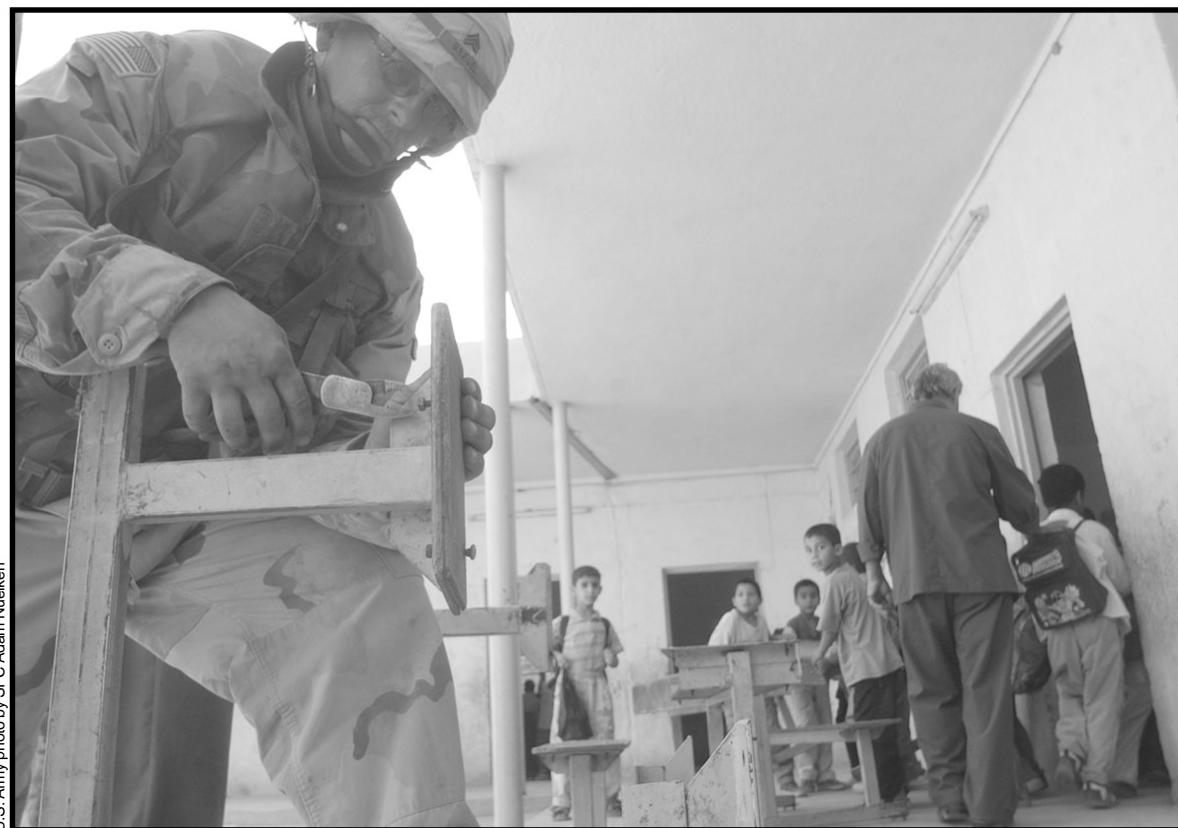
A masonry specialist with Bravo Company, 142d Engineer Battalion, replaces wooden desktops and seats at the school in Al Hurriyah, Baghdad.
